DEPARTMENT OF TRANSPORTATION**DIVISION OF ENGINEERING SERVICES**

Contract #: 04-0120F4Cty: SF/ALA Rte: 80 PM: 13.2/13.9File #: 1.28**WELDING INSPECTION REPORT****Resident Engineer:** Siegenthaler, Peter**Address:** 333 Burma Road**City:** Oakland, CA 94607**Report No:** WIR-017620**Date Inspected:** 26-Oct-2010**Project Name:** SAS Superstructure**OSM Arrival Time:** 1000**Prime Contractor:** American Bridge/Fluor Enterprises, a JV**OSM Departure Time:** 1830**Contractor:** American Bridge/Fluor Enterprises, a JV**Location:** Job Site

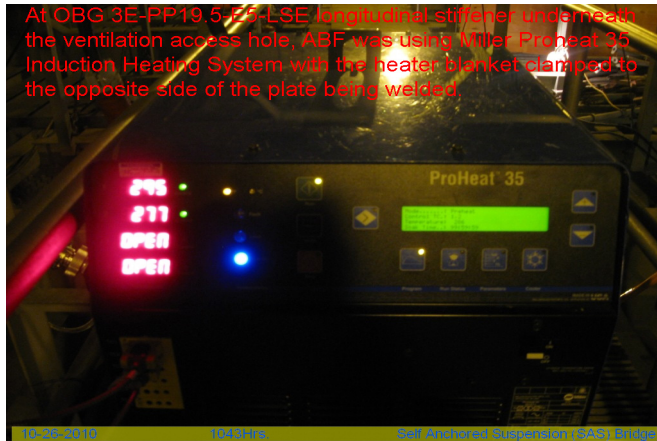
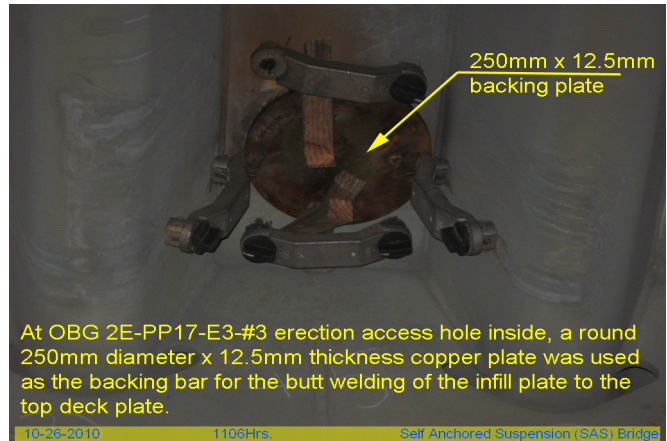
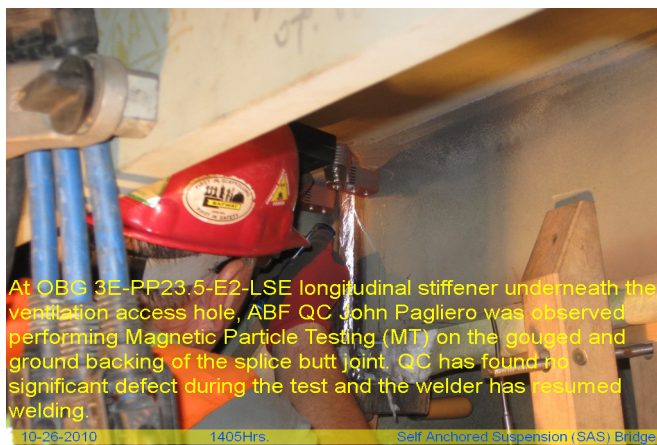
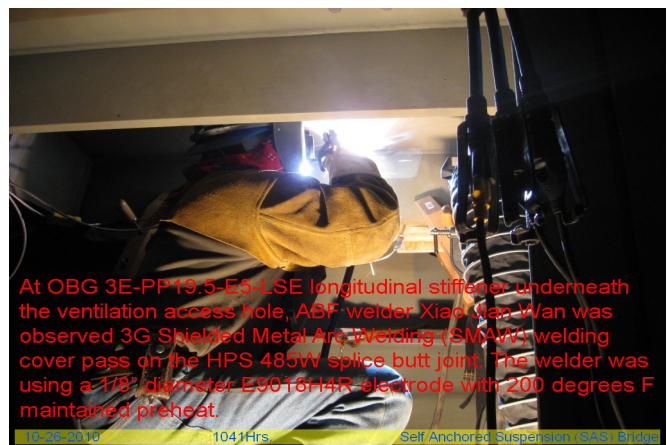
At OBG 3E-PP19.5-E5-LSE longitudinal stiffener underneath the ventilation access hole inside, QA randomly observed ABF welder Xiao Jian Wan ID #9677 perform 3G (vertical) Shielded Metal Arc Welding (SMAW) complete joint penetration (CJP) back welding cover pass on the stiffener splice butt joint. The joint has a double V joint preparation that was welded from one side using E9018H4R with 1/8" diameter electrode implementing Caltrans approved welding procedure specification (WPS) ABF-WPS-D1.5-1012-3. The joint being welded was root welded using a ceramic backing, fully welded from one side then back gouged and was ground smooth. The gouged and ground splice butt joint was also Non Destructive Testing (NDT) tested using the Magnetic Particle Testing (MT). The splice joint was preheated to greater than 200 degrees Fahrenheit using Miller Proheat 35 Induction Heating System heater blanket located at the opposite side of the plate prior/during welding. During the shift, the welder has completed back welding the east longitudinal stiffener (LSE) and held the preheat maintenance of more than 200 degrees Fahrenheit for three hours as required. After the holding time was completed, the welder has moved to west longitudinal stiffener (LSW), clamped the heater blanket and when the required preheat was attained, welded root pass implementing the same WPS as mentioned above. The QA Inspector noted the ABF QC John Pagliero was on site monitoring the in process preheats and welding parameters. During the shift, QA noted ABF QC was closely monitoring the issuance of E9018 electrodes due to its limited exposure time allowed. At the end of the shift, fill pass welding on stiffener LSW was still continuing and should remain tomorrow.

At OBG 3E-PP23.5-E2-LSE longitudinal stiffener underneath the ventilation access hole inside, QA randomly observed ABF welder Hua Qiang Hwang ID #2930 perform 3G (vertical) Shielded Metal Arc Welding (SMAW) complete joint penetration (CJP) back welding cover pass on the stiffener splice butt joint. The joint has a double V joint preparation that was welded from one side using E9018H4R with 1/8" diameter electrode implementing Caltrans approved welding procedure specification (WPS) ABF-WPS-D1.5-1012-3. The joint being welded was root welded using a ceramic backing, fully welded from one side then back gouged and was ground smooth. The gouged and ground splice butt joint was also Non Destructive Testing (NDT) tested using the Magnetic Particle Testing (MT). The splice joint was preheated to greater than 200 degrees Fahrenheit using Miller Proheat 35 Induction Heating System heater blanket located at the opposite side of the plate prior/during welding. After completing the MT of the back side excavation, the welder has resumed welding fill pass on the splice butt joint. The QA noted the ABF QC John Pagliero was on site monitoring the in process preheats and welding parameters. During the shift, QA noted ABF QC was closely monitoring the issuance of E9018 electrodes due to its limited exposure time allowed. At the end of the shift, fill pass welding on stiffener LSW was still continuing and should continue tomorrow.

At OBG 2E-PP17-E3#3 and 2EPP11-E2-#4 top deck plate 'A' erection access holes outside, QA randomly observed ABF/JV qualified welders Eric Sparks and Darcel Jackson perform CJP groove welding root pass then fill pass on the infill plates to top deck butt joints. The welders were observed respectively welding in the 1G (flat) position utilizing Shielded metal Arc Welding (SMAW) with 1/8" diameter E7018H4R electrode implementing welding procedure ABF-WPS-D15-1070. The infill plates have single bevel of 45 degrees and 5mm root gap to deck plate with 250mm diameter x 12.5mm thickness copper backing plate. During the shift, ABF QC Mike Johnson was noted monitoring the welders. ABF welder Darcel Jackson has completed welding cover pass on the 2E-PP11-E2-#4 and has moved to 2E-PP15-E2-#3 erection access hole. The welder has welded the root pass then fill pass before the end of the shift.

At 2E-PP15-E4-#1 top deck plate 'A' erection access hole outside, ABF QC Patrick Swain was observed performing Ultrasonic Testing (UT) on the welded butt joint. QC was using General Electric USM35 ultrasonic machine. QC was also observed scanning from both sides of face 'A' of the joint. During the shift, ultrasonic testing on the butt joint was completed and QC has found two rejectable indications.

At OBG 6E/7E edge plate 'B' outside, QA randomly observed ABF/JV qualified welder Fred Kaddu ID # 2188 perform CJP groove welding first time repair. The welder was observed welding in the 3G (vertical) position utilizing Shielded metal Arc Welding (SMAW) with 1/8" diameter E7018H4R electrode implementing welding procedure ABF-WPS-D15-1001-Repairs. The boat shape repair excavation having Y-dimensions of 780mm to Y-820mm was having 40mm long x 27mm wide x 11mm deep excavation. The boat shape repair excavation was preheated to more than 140 degree Fahrenheit using propane gas torch prior welding. During the shift, ABF QC Jesse Cayabyab was noted monitoring the welder. Prior welding, ABF QC Jesse Cayabyab was also observed performing Magnetic Particle Testing (MT) using Parker Contour Probe with red magnetic powder as detecting media on the repair excavation. There were no significant defects noted during the test.
